USACERL Technical Report 98/34  
January 1998

# Seismic Mitigation for Equipment at Army Medical Centers

Methods Illustrated With Examples from Madigan Army Medical Center

by  
James Wilcoski

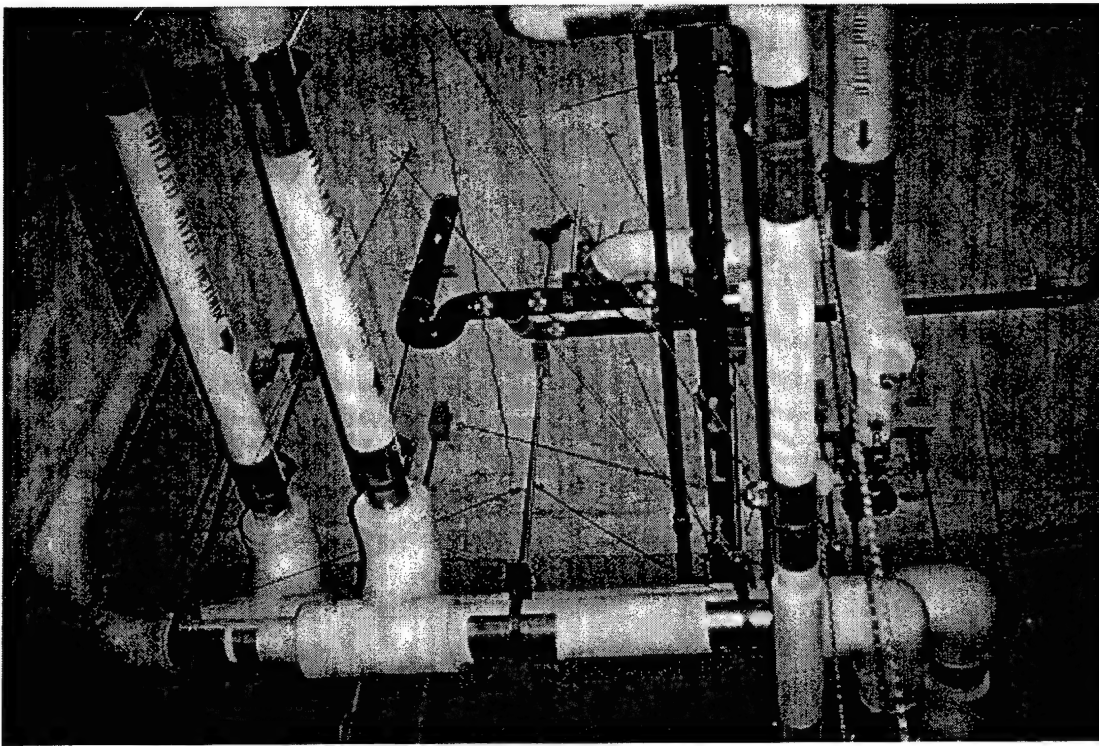
Figure 19 shows overhead suspended pipes in a mechanical room. These appear to be well suspended with tie rods and braced with cables. The cables carry tension only, so they must extend to the ceiling structure in all four directions (e.g., north, south, east, and west) in order to carry the seismically induced loads in both lateral directions. Overhead anchored equipment is supported through the ceiling by the interstitial floors. Figure 20 shows an overhead anchored telescopic arm supporting an x-ray head (collimator). The supporting rails appear to be well anchored to the overhead interstitial floor. Figure 21 is a view looking down at an interstitial floor showing a frame that distributes the load from overhead anchored equipment below to the interstitial floor. Based on the site visit it could not be determined what this frame is supporting, but it

Figure 19. Overhead suspended pipes in a mechanical room.

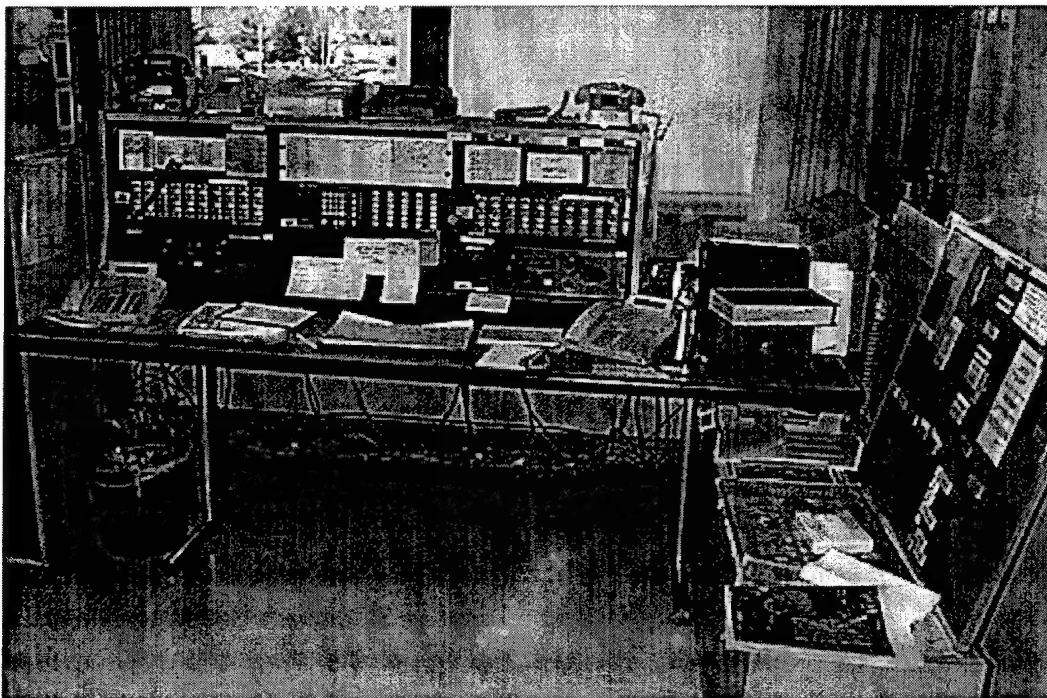
Figure 22 shows what may be the most urgent problem found at MAMC. Communications equipment at the emergency room communications center was resting loosely on a folding table, which in turn rests loosely on the floor. Figure 23 shows the edge of this equipment, which demonstrates how tall it is relative to its depth. According to the operators of this equipment, the supplier sent the wrong support cabinet. Apparently this unit was temporarily set loosely on the table, but the correct cabinet was never obtained or installed. In even a moderate earthquake the table would slide on the floor and the equipment would topple. The correct cabinet should be ordered as soon as possible. The communications equipment should be anchored to the cabinet and cabinet should be anchored to the floor. If this cannot be done immediately, the equipment should temporarily be anchored to a more stable counter. In this same room security monitors and fire detection units were well anchored, but the back of their cabinets were open. These cabinets should be closed to prevent the monitors from falling out backwards during an earthquake.

Figure 22. Equipment at emergency room communications center resting loosely on a table.

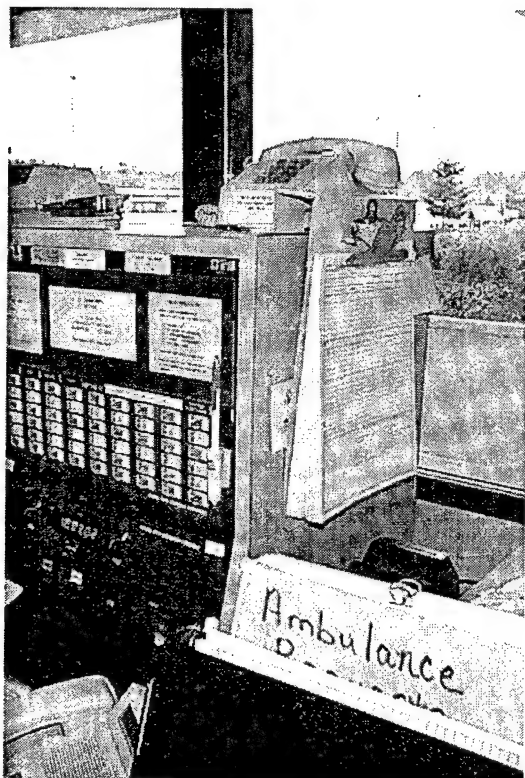
Figure 23. Side view of communications center equipment.

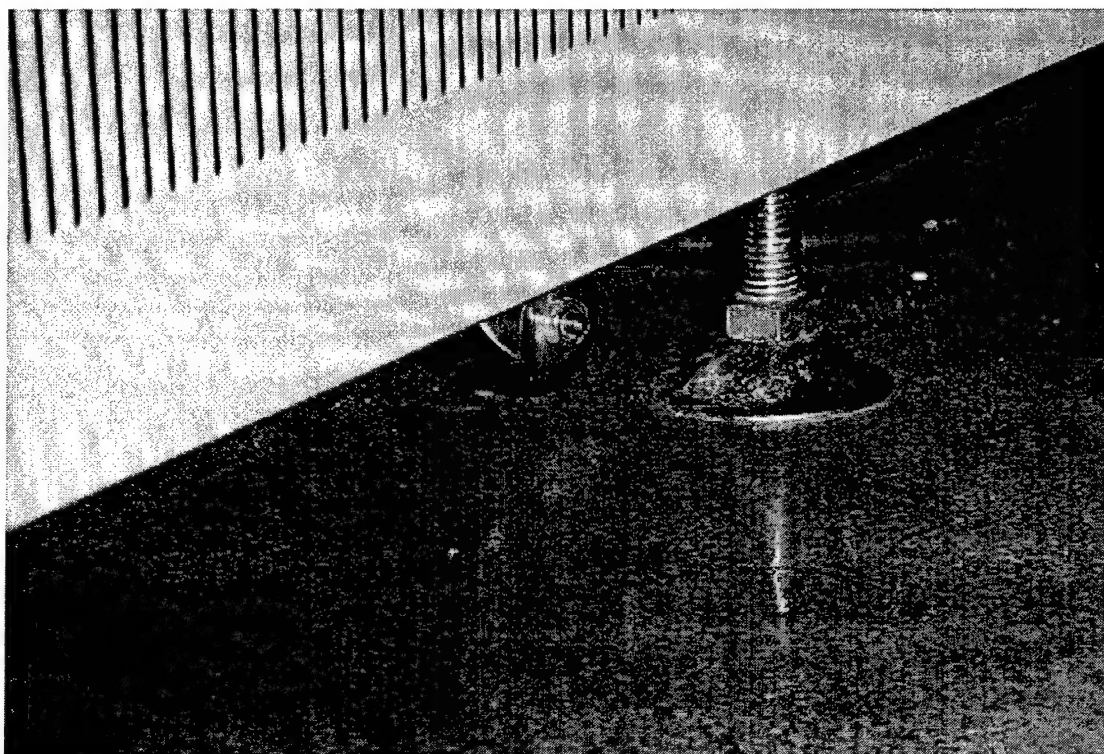
Figure 25. Close-up showing lack of anchorage for the Digiscan equipment.

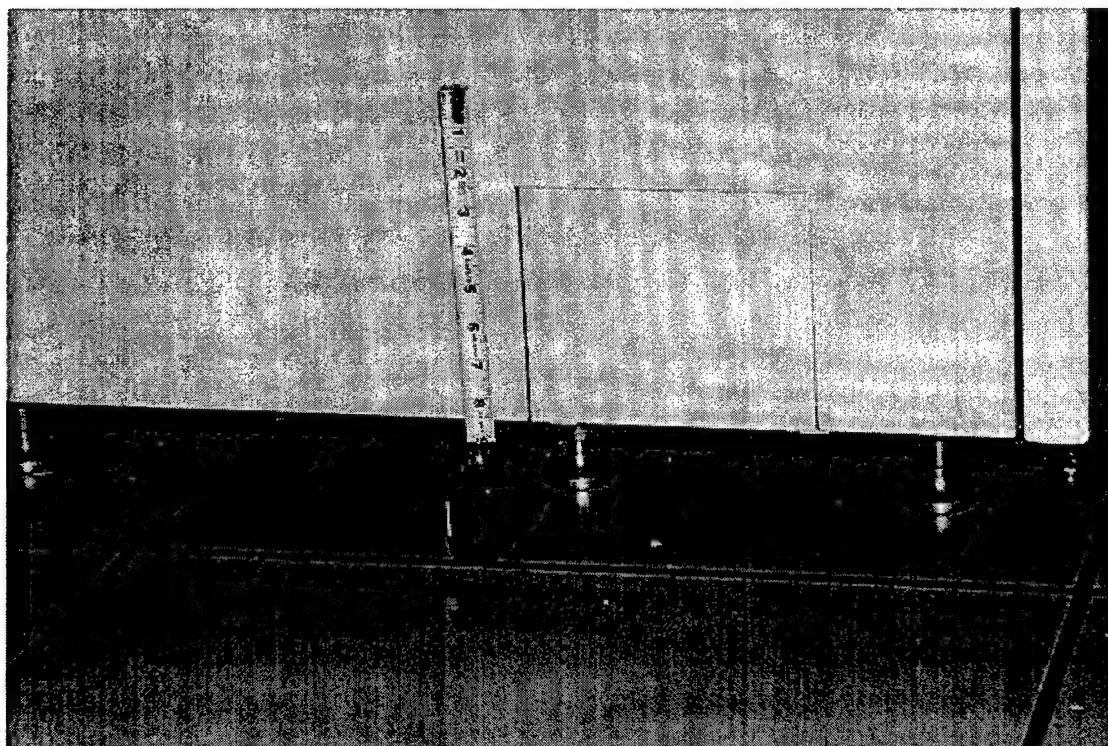
rests loosely on the computer floor (Figure 27) and is of critical importance to medical staff at MAMC. The supporting computer floor tiles are loosely supported on a stringer system frame. Computer floors supported on stringer system frames apparently perform well in earthquakes. Other computer floors are supported on a stringer-less system where a post supports and should be fastened to each corner of the floor tiles. These posts must be braced to resist lateral seismic motions. Often the fasteners are left out, and in earthquakes loose tiles near equipment could shift off their posts, and drop to the floor below. This in turn would allow equipment to shift and drop into the fallen tile area on one side, and then fall over. All critical equipment should either be bolted to the floor below the tile using a tie-rod or, for lighter equipment, bolted to individual floor tiles. Figure 28 shows a mainframe computer, supported on a computer floor that was tested on the USACERL Triaxial Earthquake and Shock Simulator (TESS). This was the standard field installation for seismic design where the tiles were fastened to the computer floor posts, the posts were braced, and the computer was fastened to the floor below using a tie-rod that penetrated the computer floor surface. This configuration performed well in seismic qualification tests.<sup>3</sup>

Figure 27. Close-up showing lack of anchorage for the optical disk system.

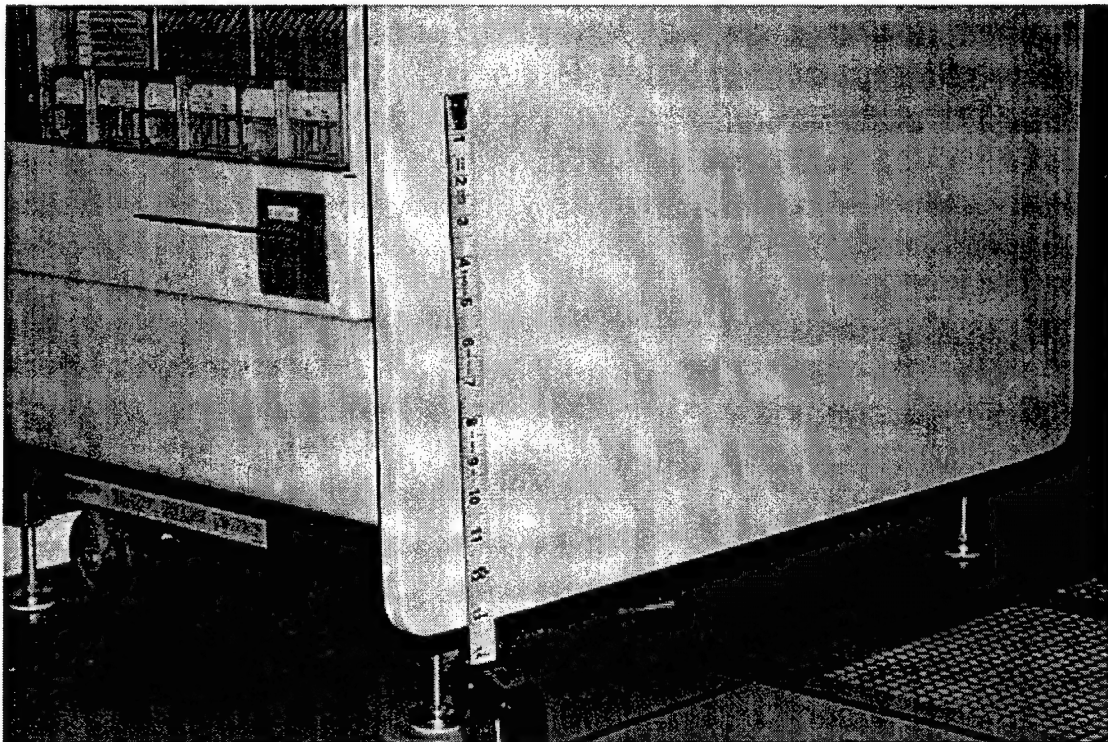
Figure 30. Close-up showing a lack of anchorage for the mini-computer.

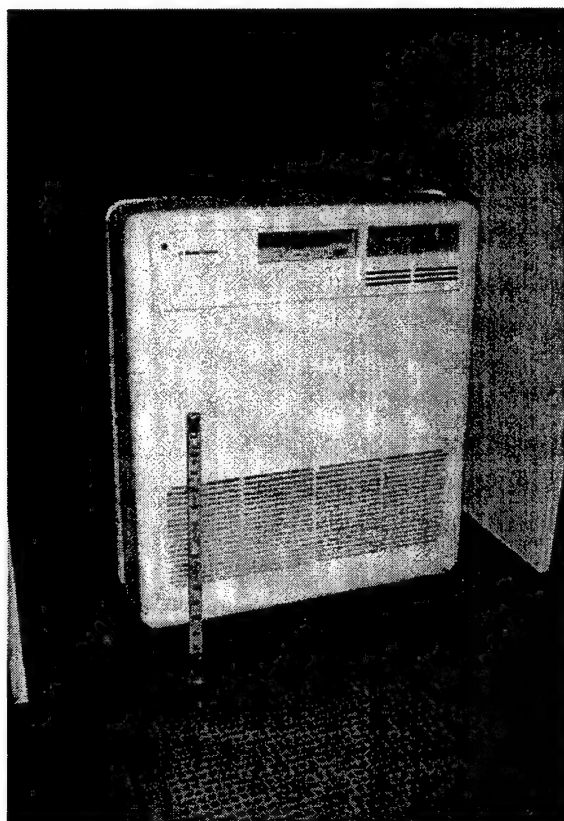
**Figure 32. Computer that records MRI results, anchored to a single computer floor tile.**

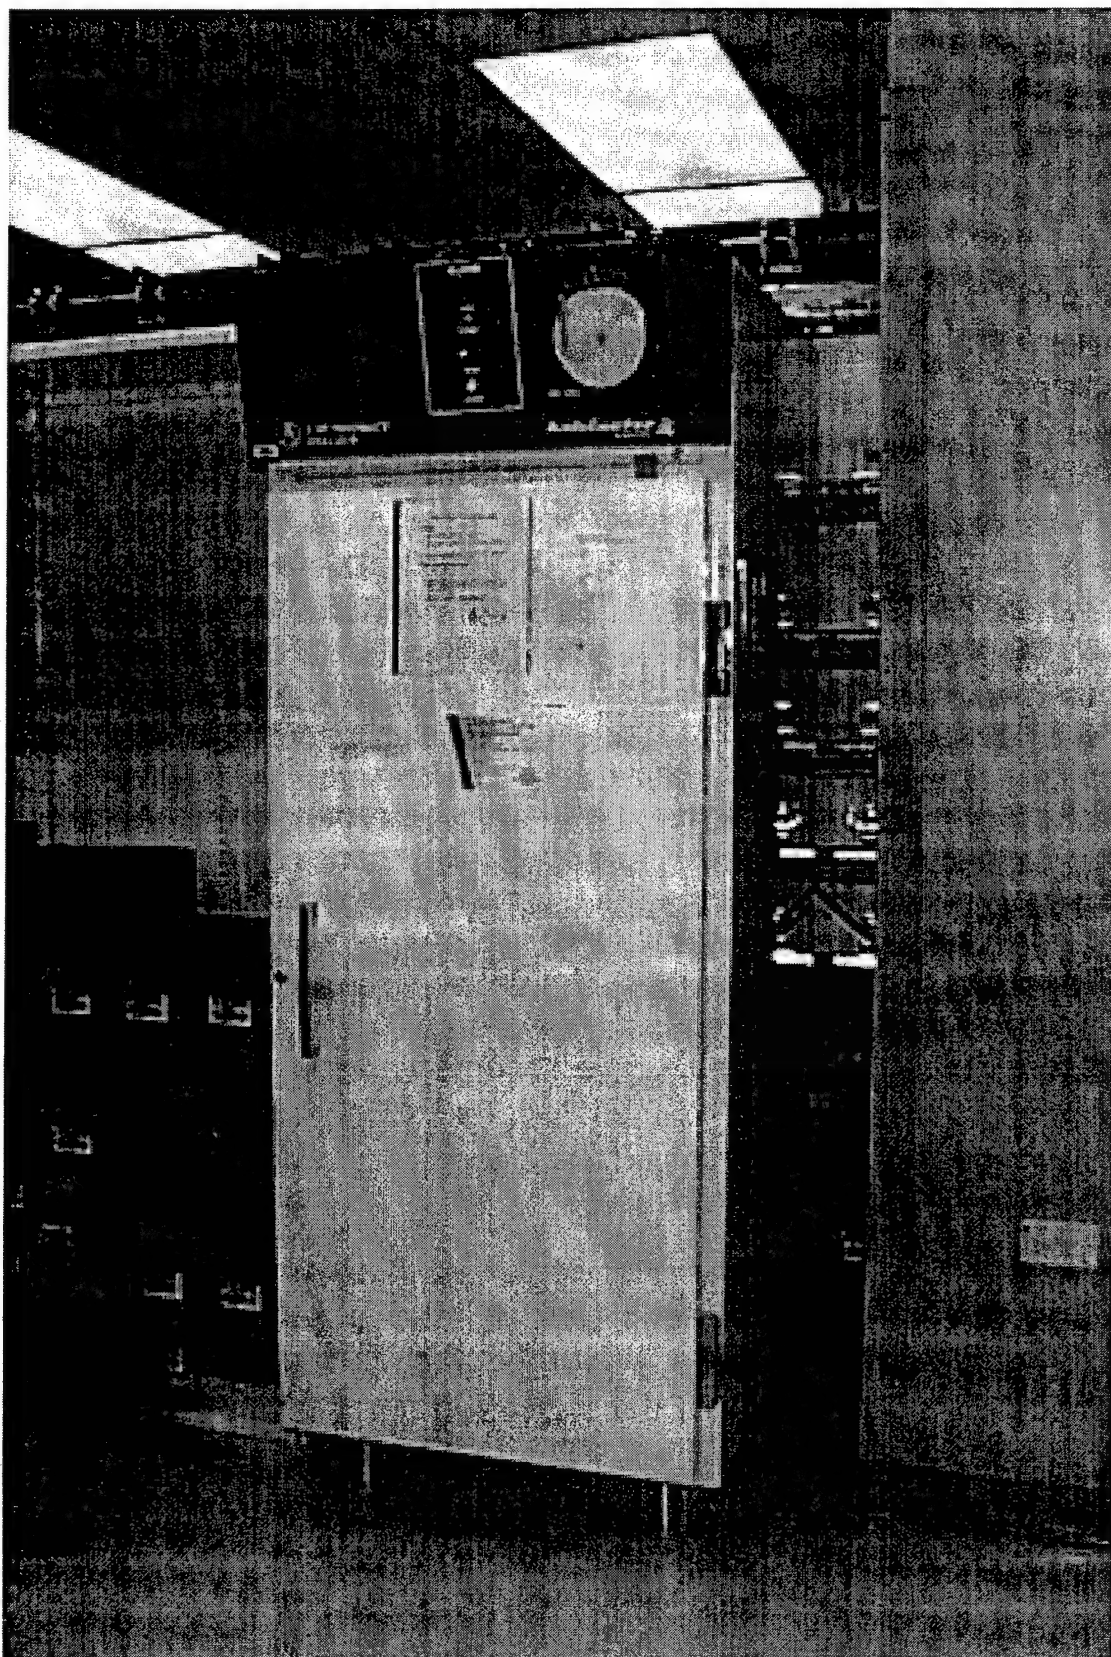
pharmacy freezer that is quite tall, has a small footprint, and is unanchored. (It should be noted that the kitchen also has many tall, narrow unanchored coolers and freezers similar to this.) These should either be braced (see Figures 4 and 14) or anchored to the floor. Figures 34 and 35 show tall, narrow shelves. These shelves can be simply braced by bolting them to a wall or to each other in a T or L configuration (in plan). The two shelves shown in Figure 34 could be braced by simply bolting them to each other near their tops and bottoms. (They will form a T configuration in plan if left in the positions shown in this figure.) Tall shelves such as those shown in Figures 34 and 35 could also be braced to the ceiling structural system. Shelves that are at least seven feet tall configured in parallel rows can be braced to each other perpendicular to the row and across the tops. Figure 36 shows small storage bins in the pharmacy. These bins have a small lip at the front. Storage bins like these should have a higher retainer edge to keep contents in the bins. The same retainer edge should be used for horizontal shelves throughout MAMC. It is recognized that such a retainer edge would make shelves slightly less accessible, but this is a relatively small cost to protect important medical assets. This approach is used in other types of facilities in active seismic regions, such as libraries in California which often have wires in front of books to hold them in place during an earthquake. Lightweight contents can also be held on shelves with cabinet doors with latches.

Figure 33. Tall unanchored pharmacy freezer with a narrow footprint.

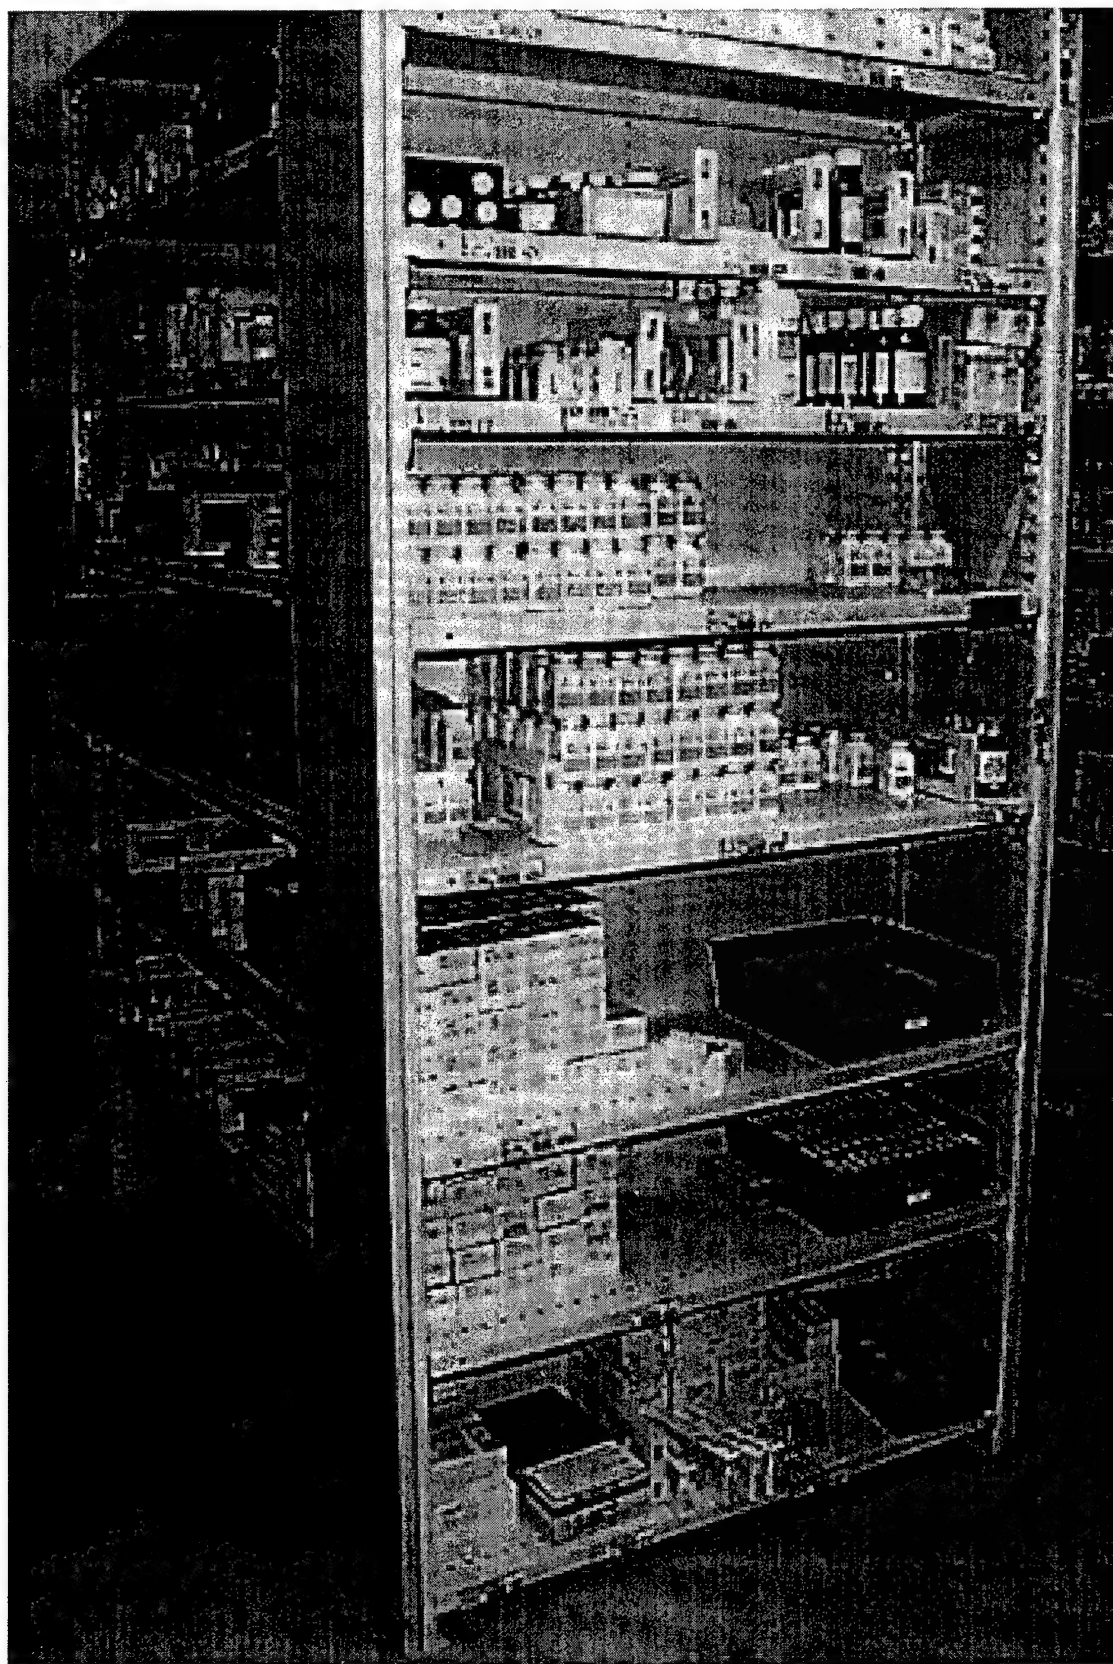
Figure 34. Unanchored tall narrow shelves that may be secured in their present configuration.

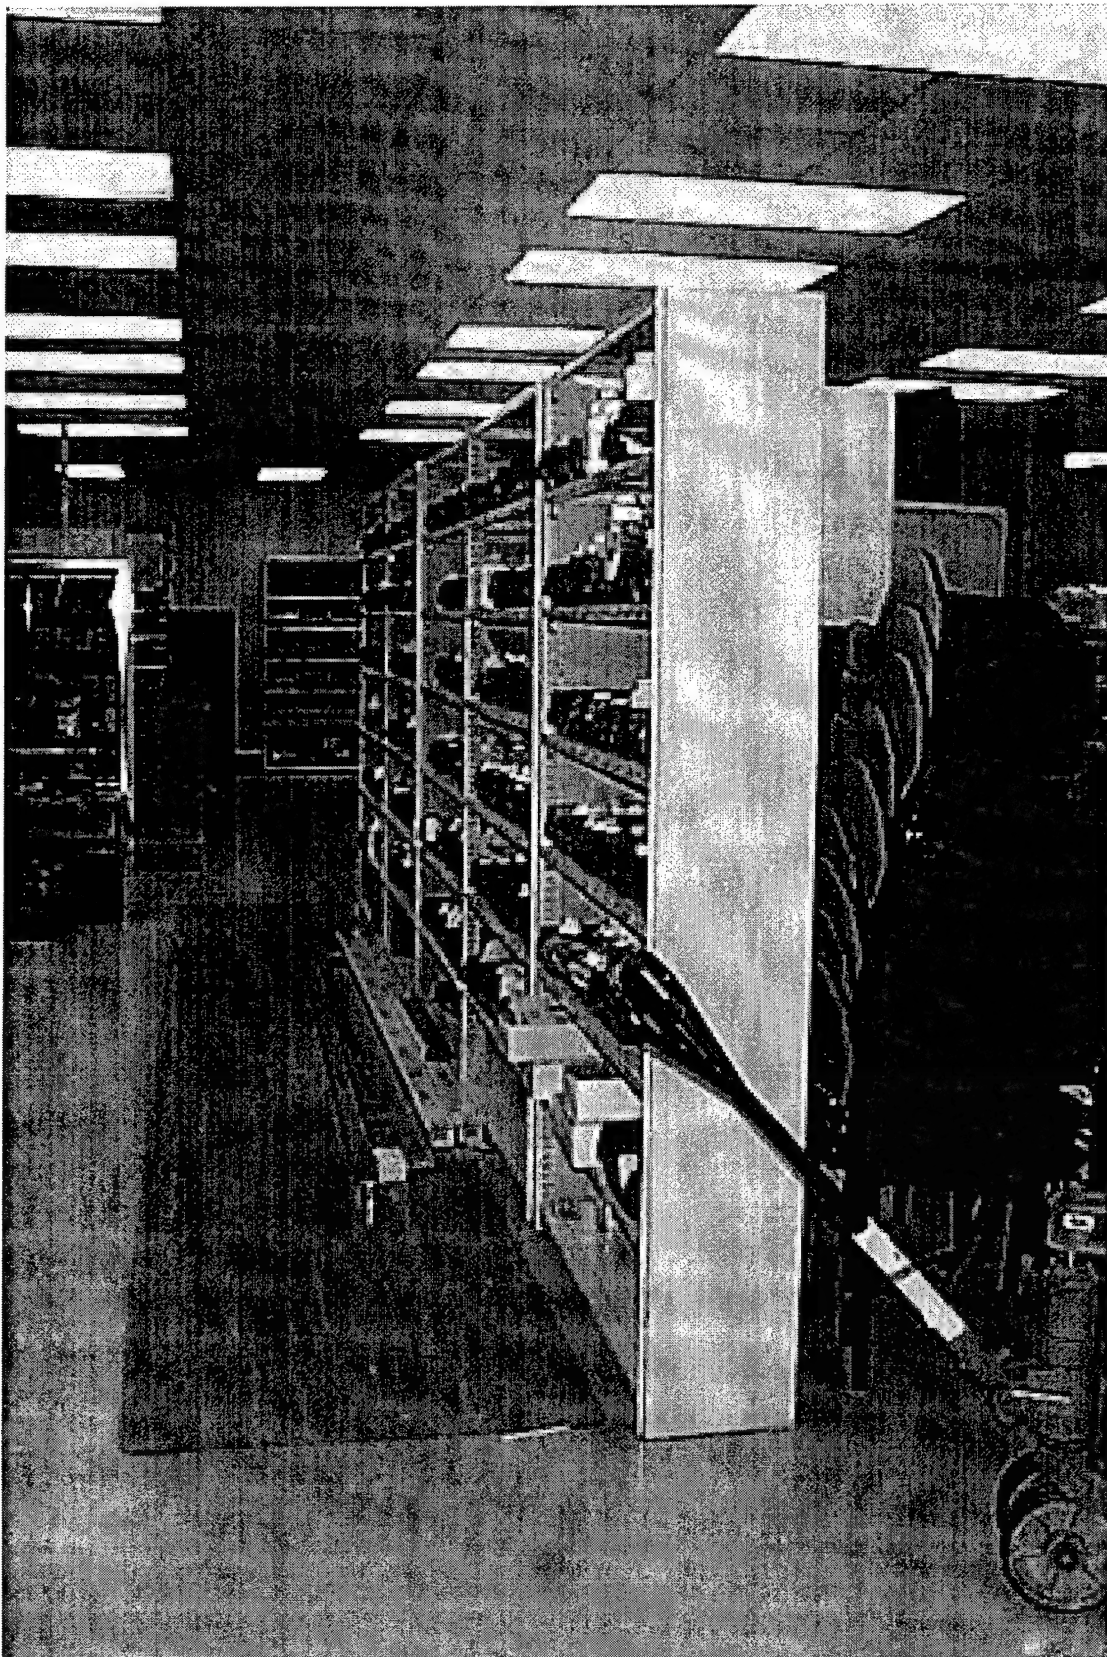
Figure 35. Unanchored tall narrow shelves.

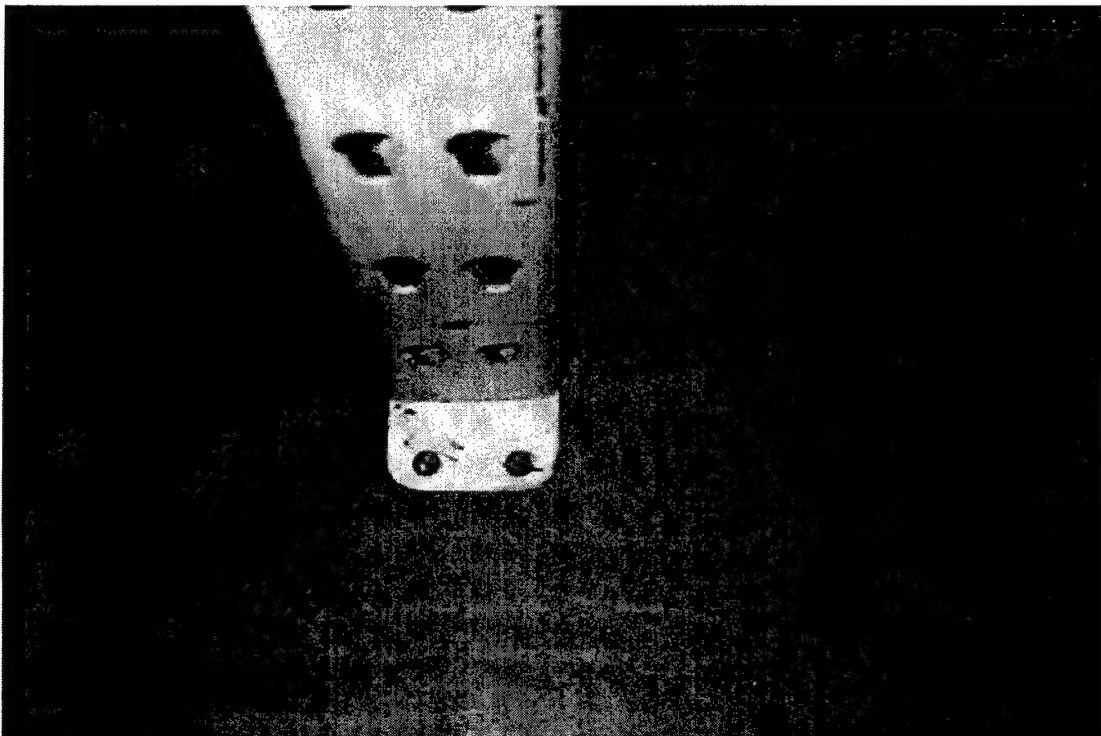
Figure 38. Close-up of logistics area storage racks showing lack of anchorage.

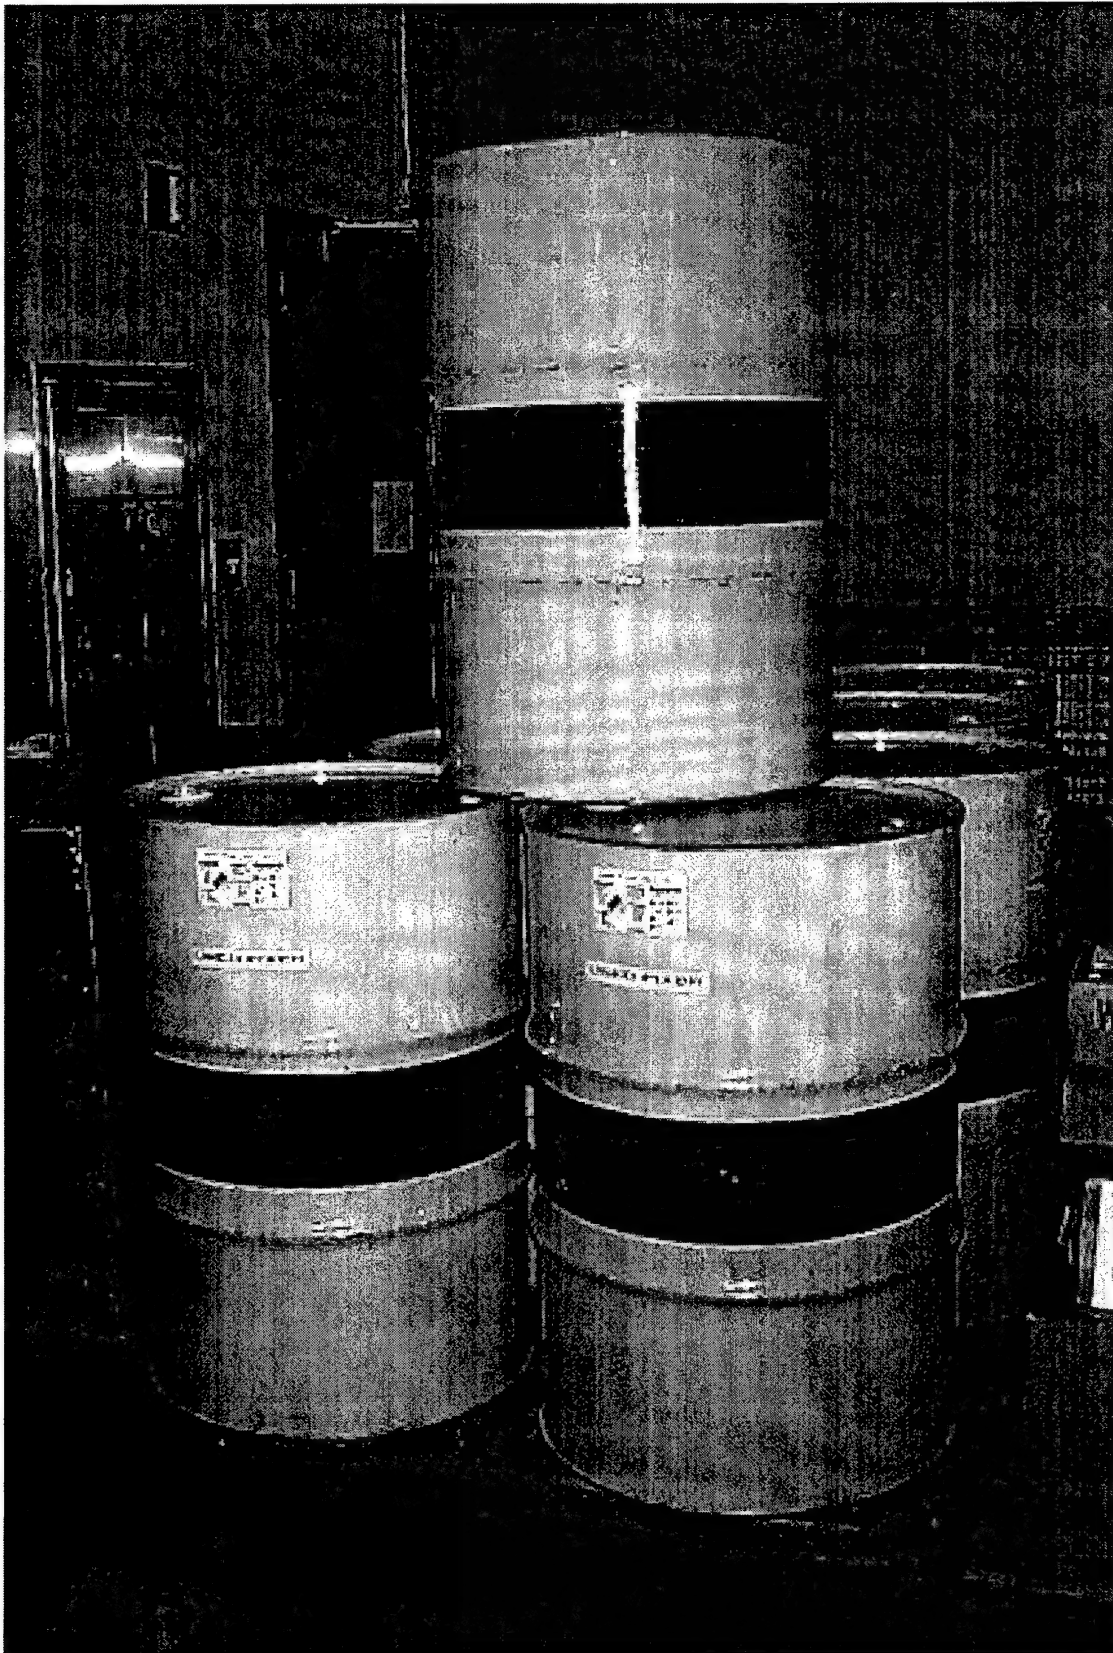
Figure 39. Loosely stacked barrels.

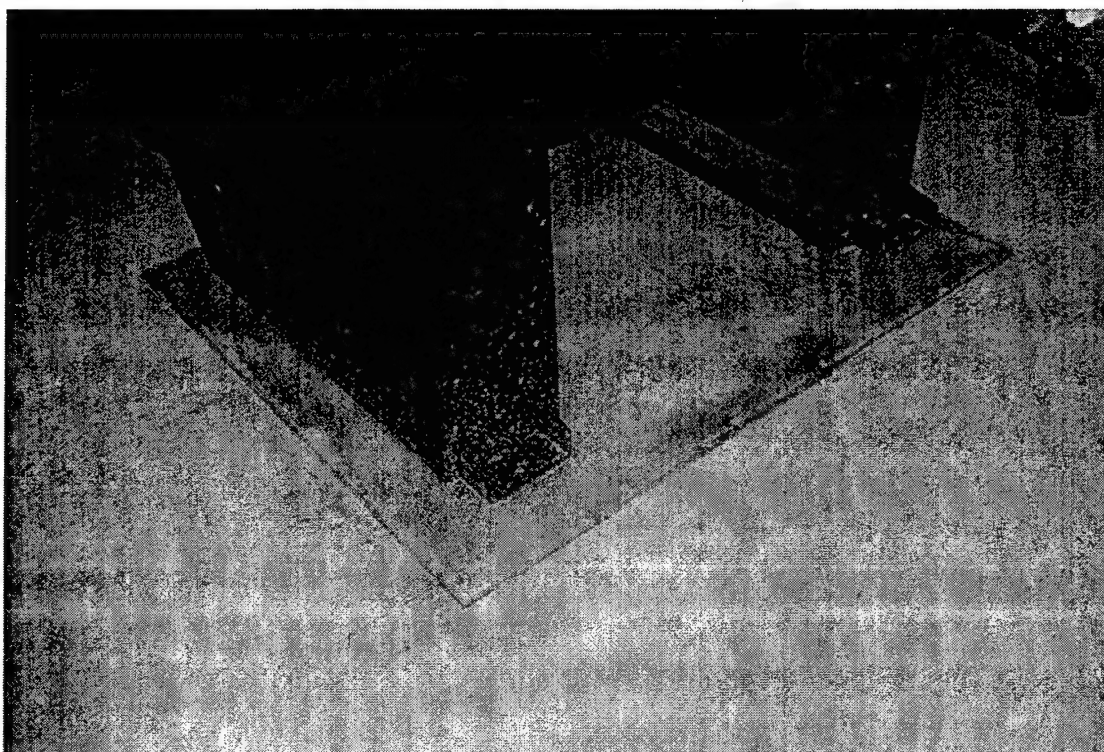
Figure 41. Close-up of milling machine legs showing bolt holes for anchorage.

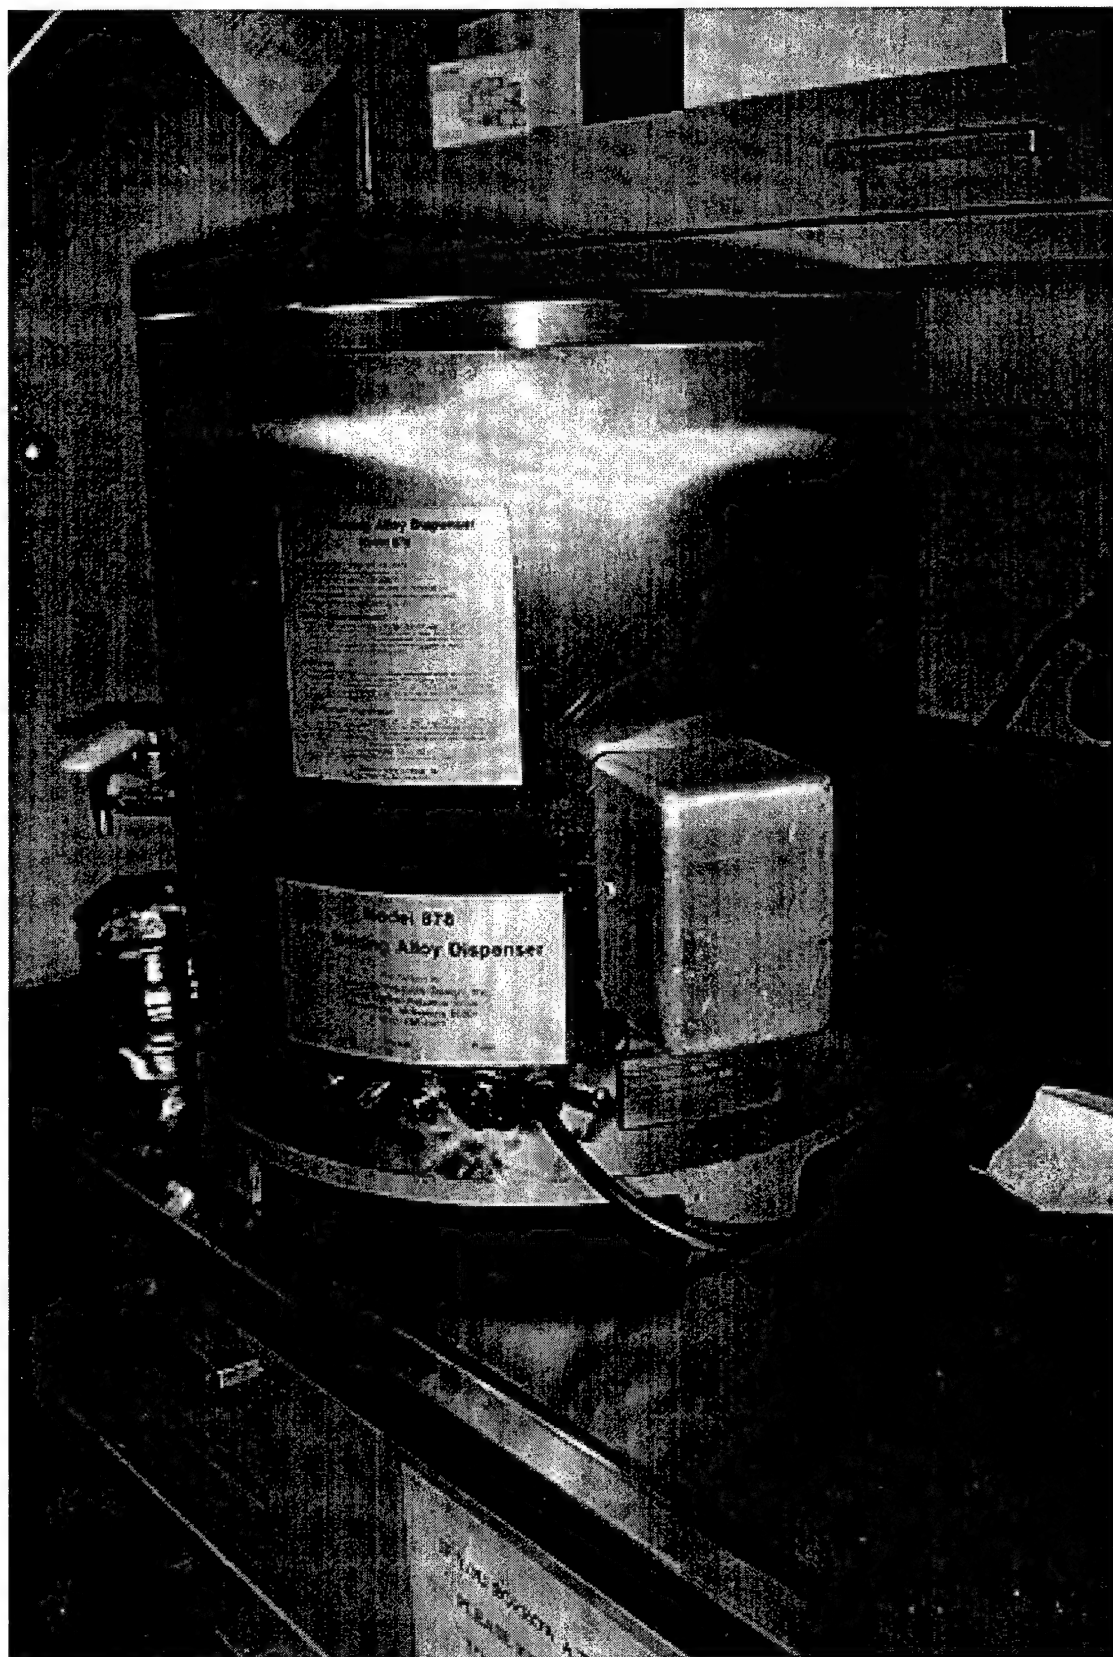
machine can easily be bolted to the floor. Figure 42 is a low-melting alloy dispenser, providing molten lead for casting radiation shielding blocks. This unit weighs over 100 lb (45 kg), and is resting loosely on the countertop. It should be anchored to the countertop or braced back to the wall. Figure 43 shows typical laboratory equipment — both the cabinet and its contents should be anchored. Also note the file cabinet on the right side of this figure — it is unanchored and may easily topple, blocking escape from the door next to it.

Figure 42. Low-melting alloy dispenser, shown resting loosely on countertop.

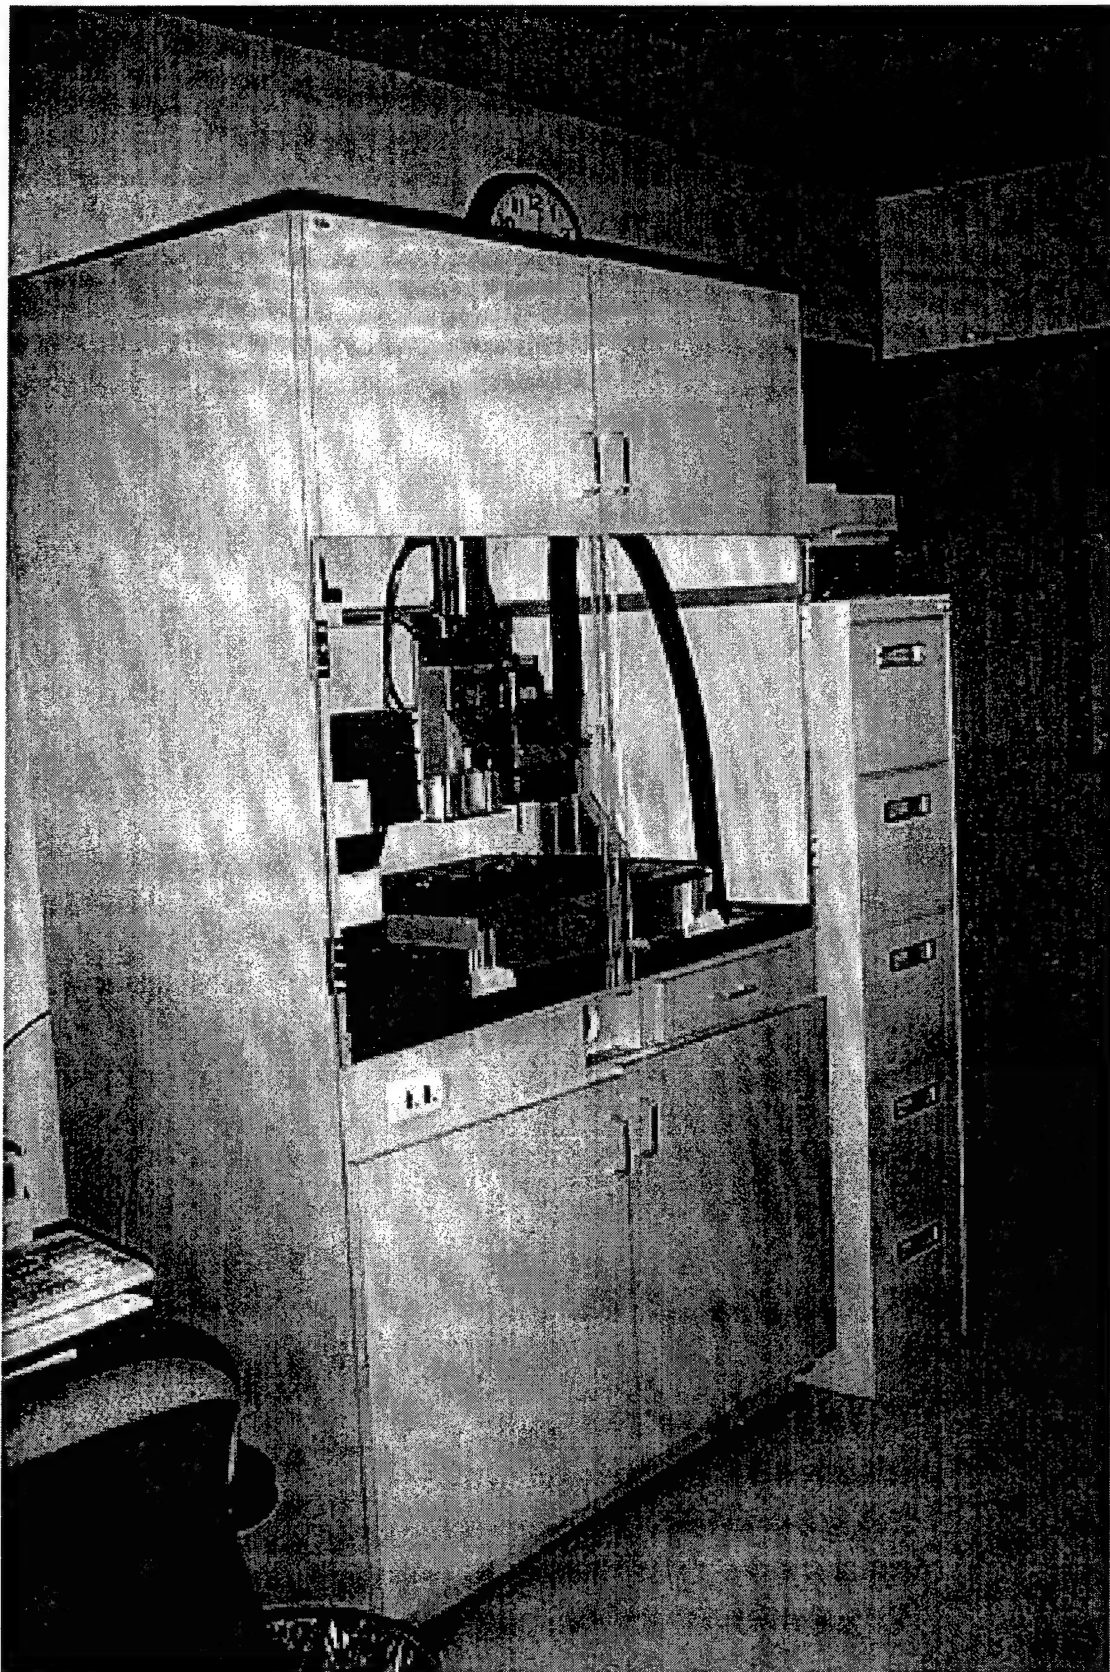
Figure 43. Unanchored typical laboratory equipment.

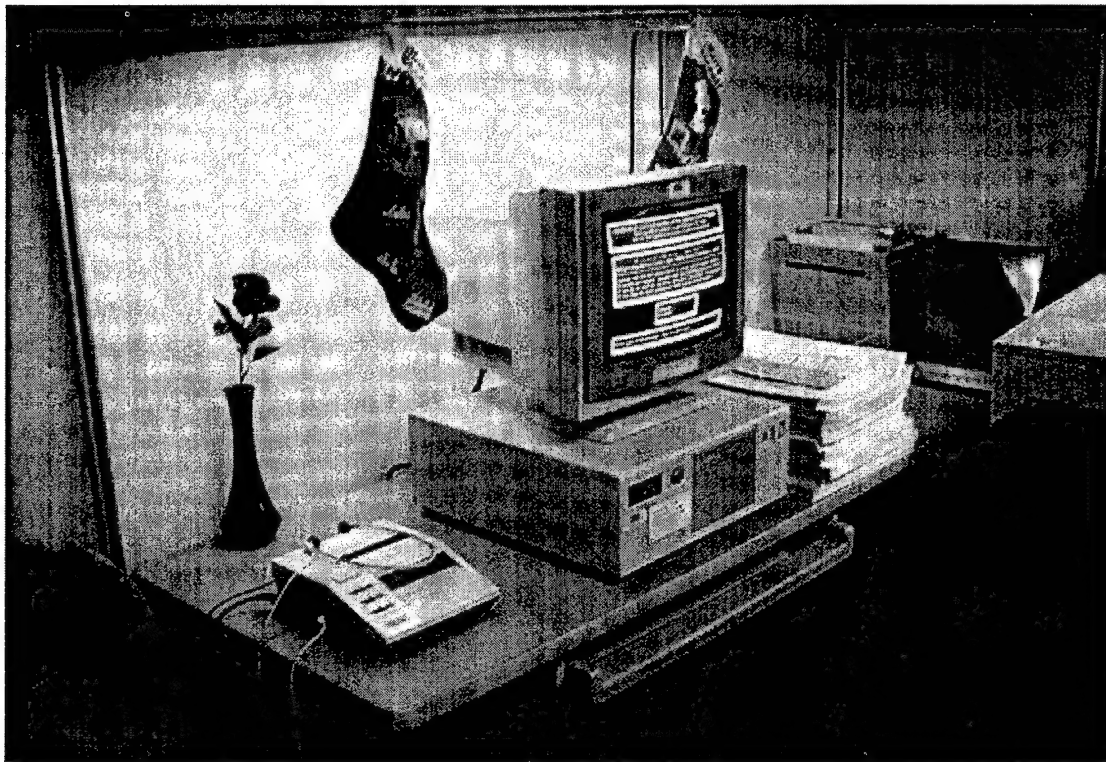
**Figure 44. Unanchored desktop computer CPU and monitor.**

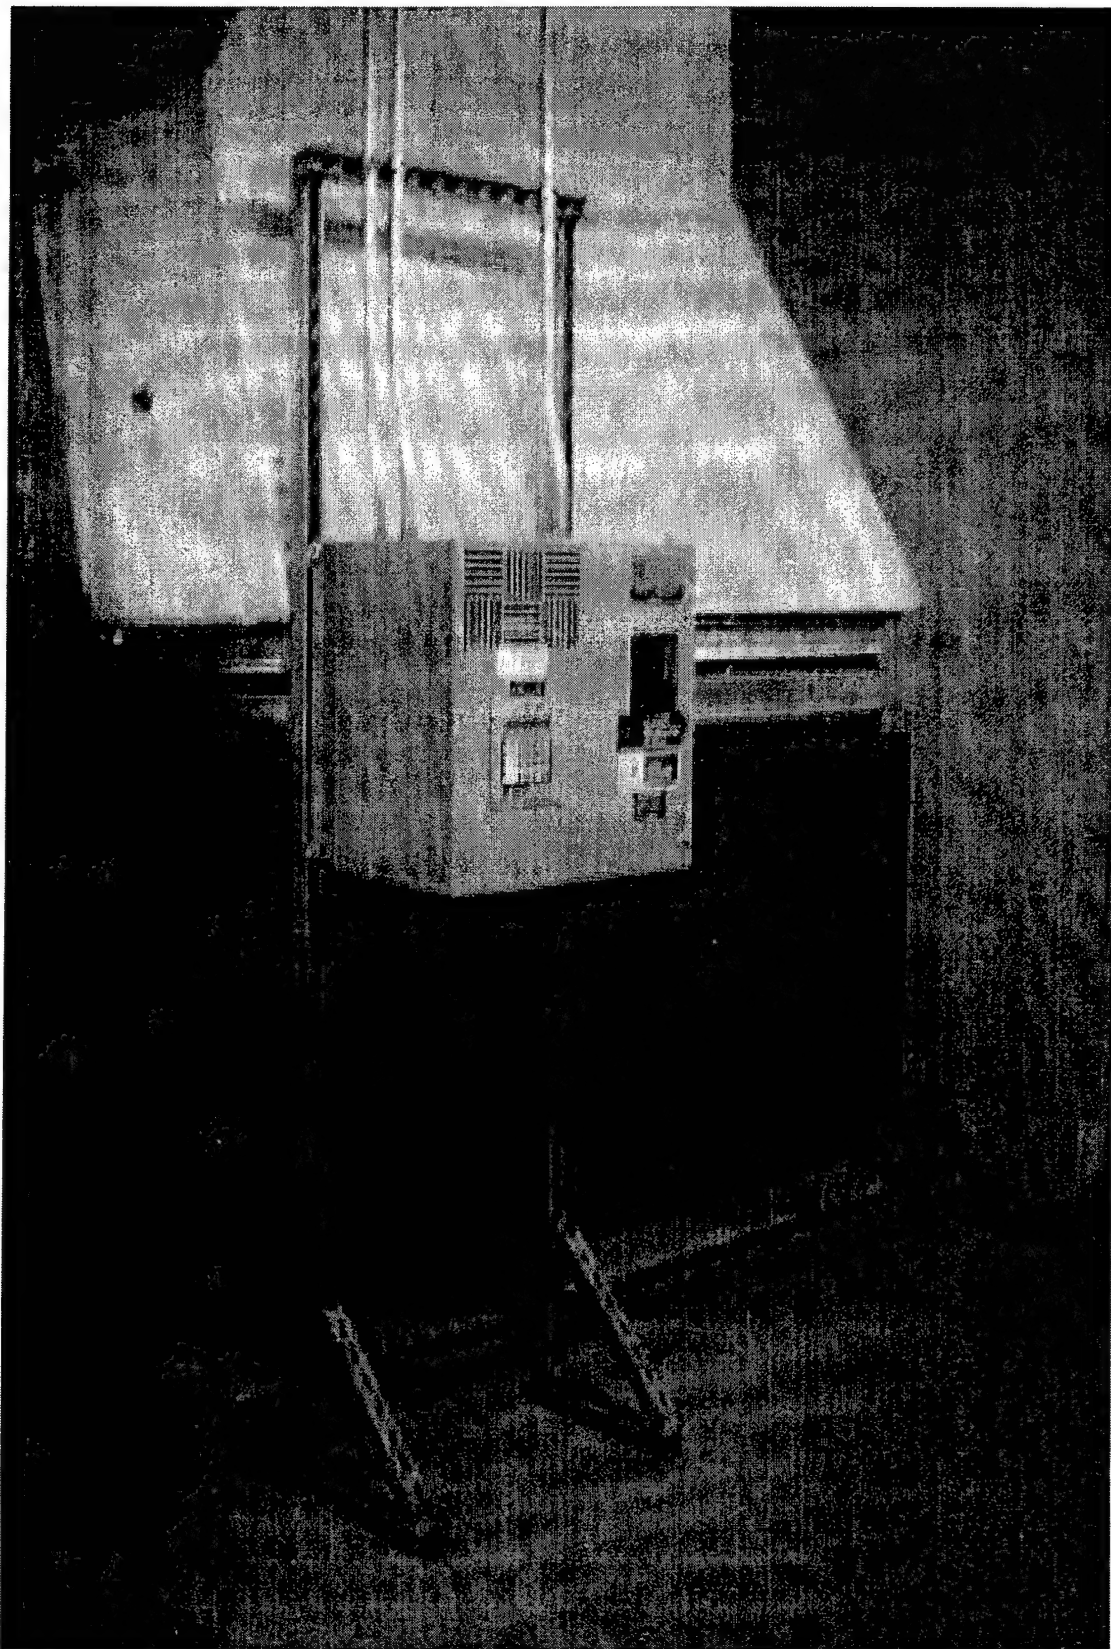
Friction clips, which are often used to support or brace cable trays and various other equipment, should be avoided. Figure 46 shows a Unistrut frame supporting an air-handling unit control panel in a mechanical room. The brace at the bottom of this frame uses friction clips to connect the diagonal members. These clips may work loose after several cycles of seismically induced motions. Such connections should be made with standard fasteners rather than these clips.

Figure 46. Unistrut frame with friction clips supporting air handling unit control panel.
